# ***A Few Mine Related Considerations For An Enhancement Of SR 80, Near Bisbee Arizona***

***Nicholas M. Priznar***, *Engineering Geologist*, Arizona Department of Transportation

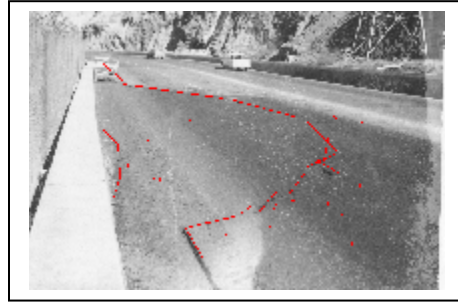
Two years after ADOT Project F-016-1 (11) was constructed in 1964, a 200-foot long arcuate crack propagating toward centerline had been reported and a landslide was progressing along a parallel trace of the Dividend Fault zone.

The stability of the site has been an intermittent concern since construction in 1961. The records indicate that there was some disagreement over the methods to mitigate the slide conditions. The project file contains a number of letters that refer to maintenance work by both the mining company and ADOT through 1966. In 1987, a Geotechnical Investigation (Report No. 87-13) was conducted to investigate a 150 ft long crescent shaped crack in the pavement in the same general vicinity. The report indicated that in 1978, the mining company repaired a section of settling highway by installing steel bars into grouted drill holes. A large “slippage of the pit slope was observed” Inclonometers were installed at the site and have been monitored intermittently since that time.

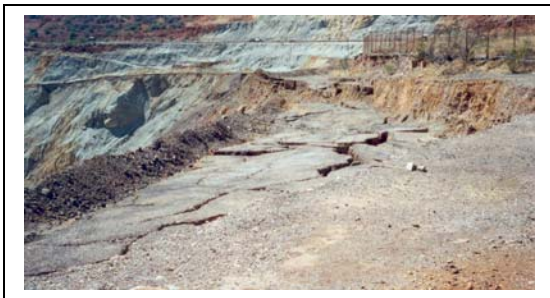
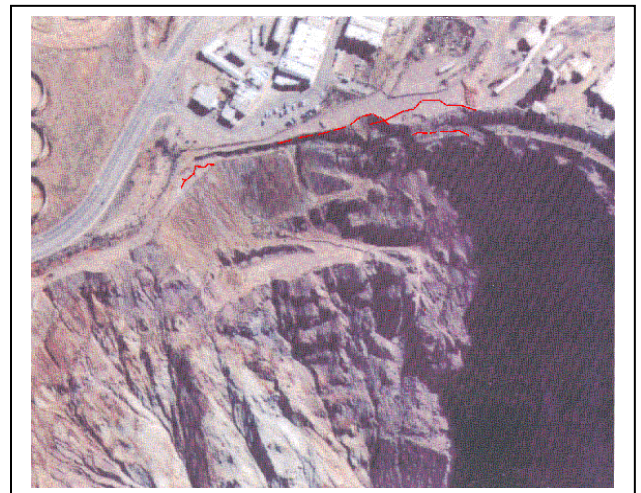
In February 2003, a Design Concept Report was issued to provide new pedestrian access along SR 80 to connect the communities of Old Bisbee and Lowell. Unfortunately the enhancements proposed to widen the highway on the existing embankment section that formerly experienced settlement and landslide activity. Additionally, the mining company indicated that there was concern about subsidence in the Lowell area. A site visit to the area confirmed the presence of tension cracks outside the right of way fence in several sections of the Lavender Pit in proximity to the proposed improvements.

**Above:** Settlement features developing inside fence line. **Right:** Aerial view of the Lavender Pit near Lowell. Apparent distress features highlighted red

Because this project was only in the pre-design stages, it was convenient to bring these conditions to the attention of the project stakeholders and effectively suggest alignment changes to avoid a potential problem.

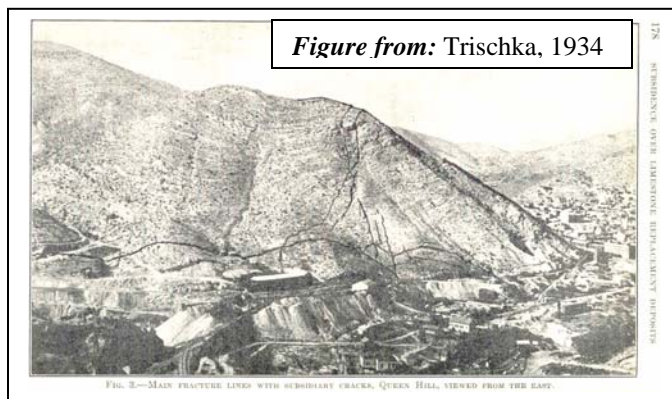
At the time of my involvement with the design of the new pedestrian facilities, a set of air photographs for this section of the highway became available. I examined the photographs and enlarged the images (with a digital scanner) of the route of the proposed improvements to look for signs of highway infrastructure distress. Besides the settlement features apparent in the area just beyond the fence in the Lowell area, numerous other fissures, crack and wide fractures were exhibited north east of the highway in the vicinity of the Queen Mine Tour. (Queen Hill) Initial reactions to the observed features were eye opening. However a diligent records search indicated that these features were reported in the technical literature over 70 years ago.

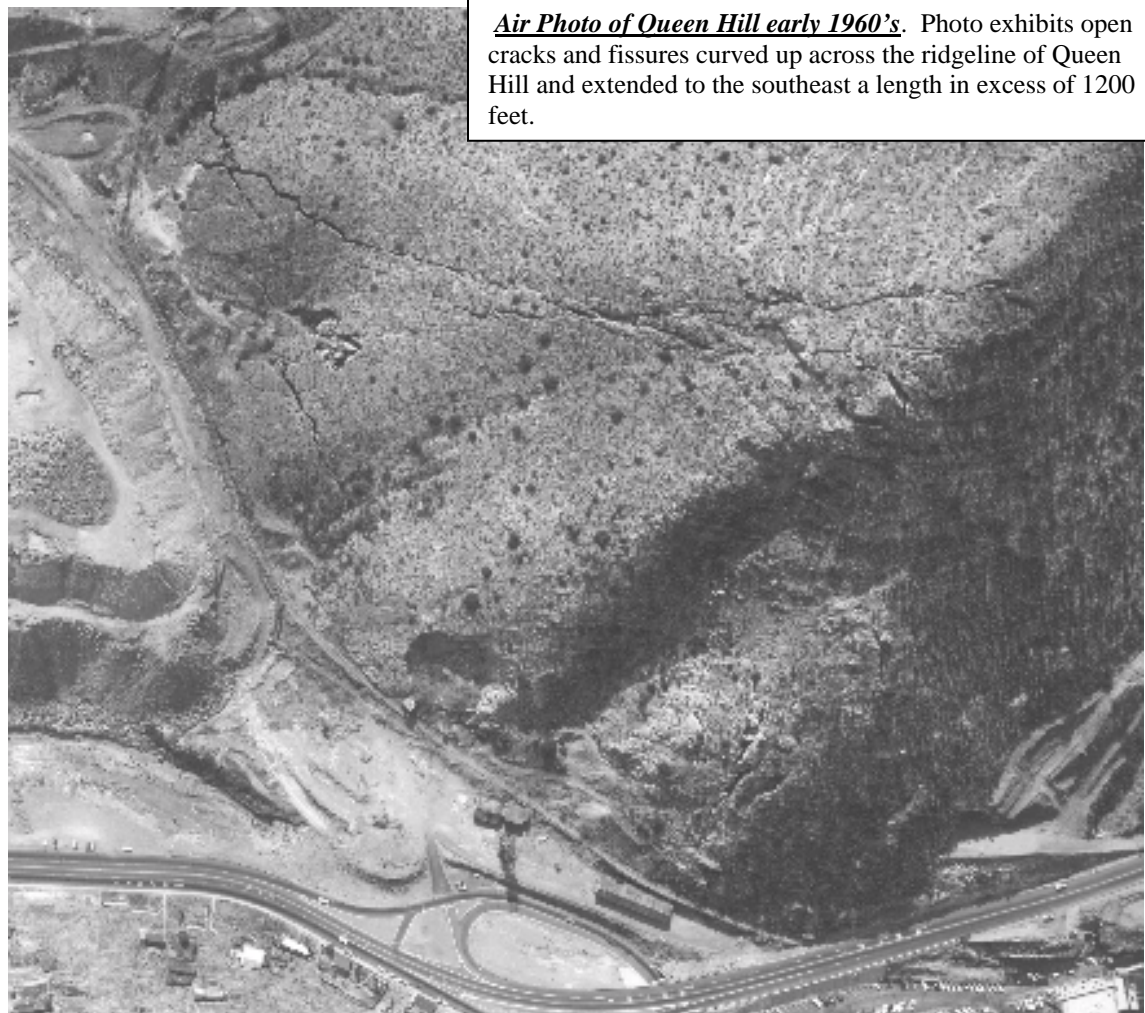
When originally reported by Carl Trischka in 1934, a display of crescent shaped open cracks and fissures curved up across the ridgeline of Queen Hill and extended to the southeast a length in excess of 1200 feet. Although no mention of the width of the fissure is given, historical photographs in the vicinity suggest they may have reached at least 10 feet in width. Mr. Edward Wisser (1927) in *Economic Geology* Vol. XXII, believed that a process referred to as “Oxidation Subsidence”, preweakened the Paleozoic sedimentary rocks by creating void space and initializing vertical and semi-horizontal (doming) discontinuities in the rocks in the time period before mining began. The mining of the deposits and the methods available at the time reactivated these incipient weaknesses and accelerated subsidence in the area.

**Air Photo of Queen Hill early 1960's.** Photo exhibits open cracks and fissures curved up across the ridgeline of Queen Hill and extended to the southeast a length in excess of 1200 feet.
